**REHABILITATION OF THE MANSOUR
PUMP STATION**

UNDER THE COMMANDER'S EMERGENCY RESPONSE PROGRAM

BAGHDAD, IRAQ

**SIGIR PA-07-111
JANUARY 24, 2008**

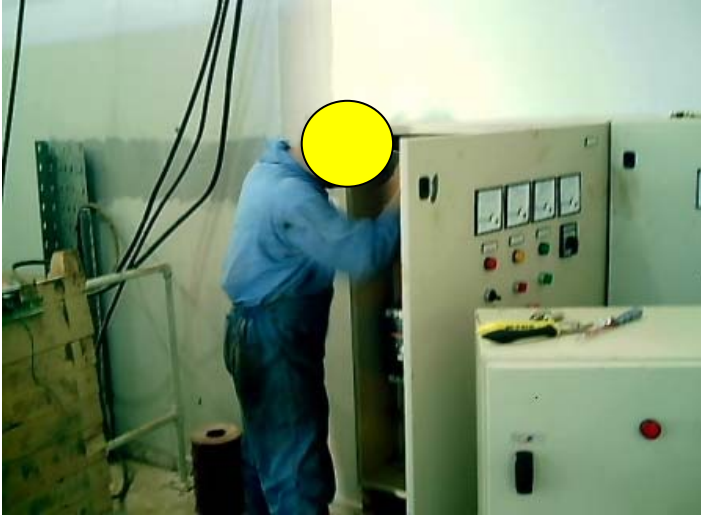
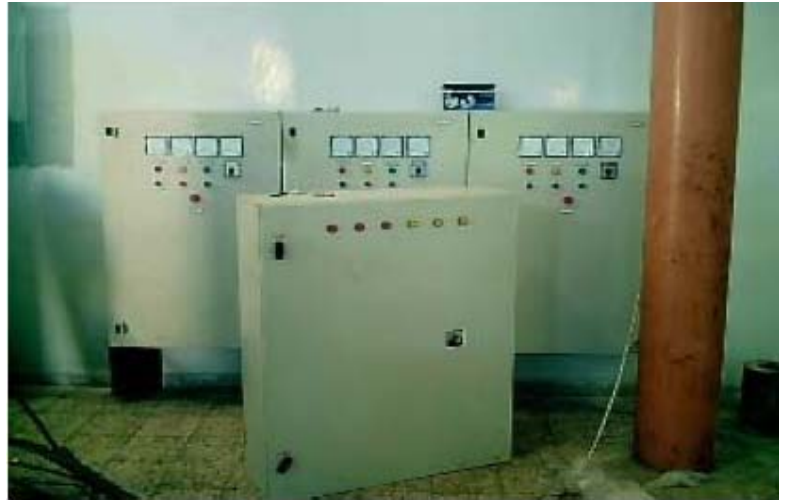
Site Photos 1 and 2. Contractor installation of the electrical control panels and the installed control panels.
(Photos courtesy of USACE)

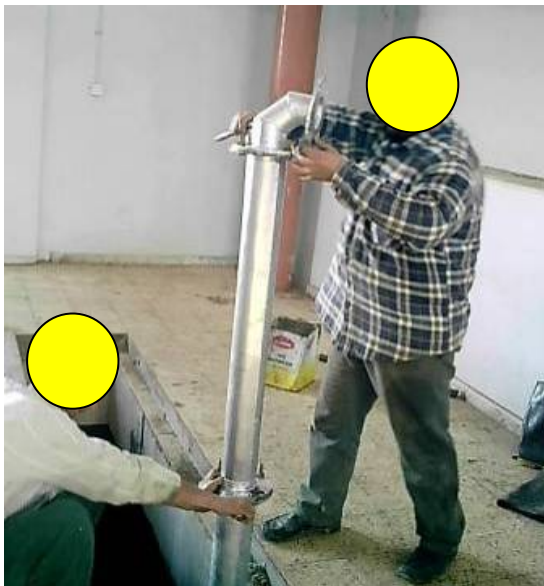
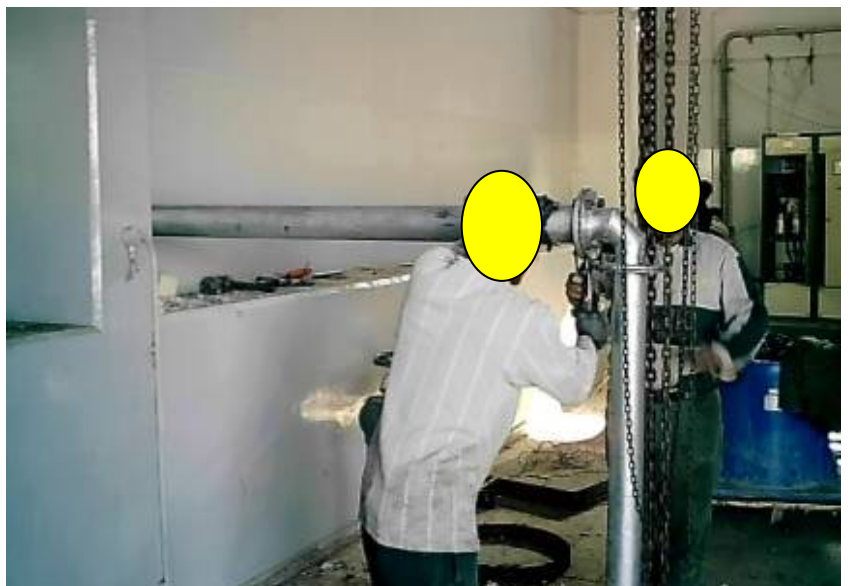
The USACE contract file documentation provided photographs of the contractor while installing the galvanized pipe for the submersible pump (Site Photos 3 and 4). According to the quality control (QC) report, dated 27 January 2007, the contractor “complete install the Submersible”; however, no quality assurance (QA) reports mentioned the installation of the contract-required submersible pump. The QC report did not provide any photographic evidence to document the installation of the submersible pump.

Site Photo 3 and 4. Contractors installing the galvanized pipe for the submersible pump.
(Photos courtesy of USACE)

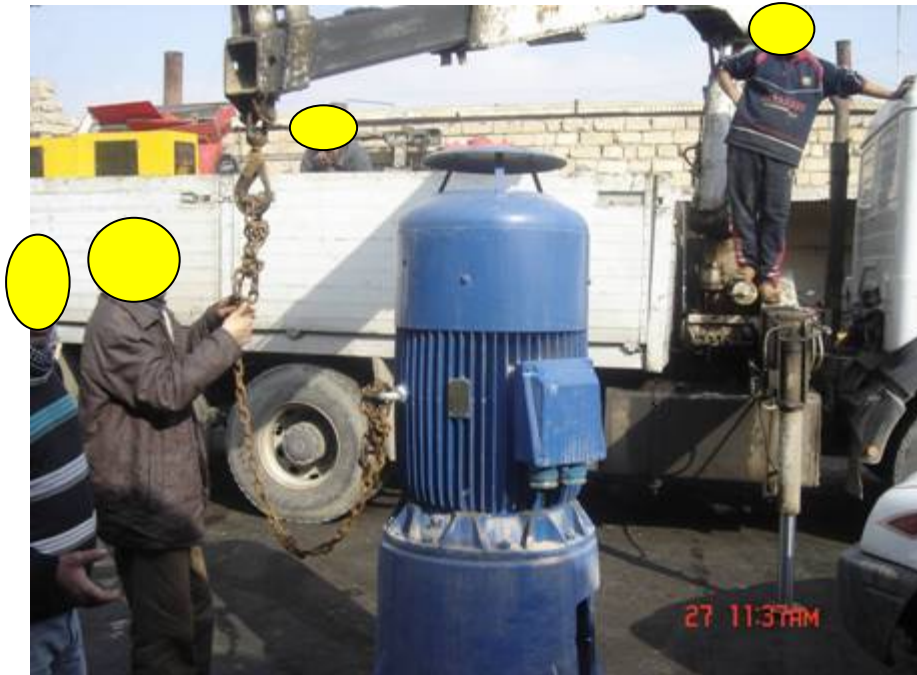
The USACE contract file lacked documentation that the contractor installed the government-provided 350 mm vertical pump. Several QC reports mentioned the completed installation of the 350 mm vertical pump; however, there were no photographs provided to support this claim. The QC reports documented the delivery of the new motor for the 350 mm vertical pump (Site Photo 5), but there were no photographs of the actual contract-required vertical pump.

**Site Photo 5. Delivery of the new motor for the 350 mm vertical pump.
(Photo courtesy of USACE)**

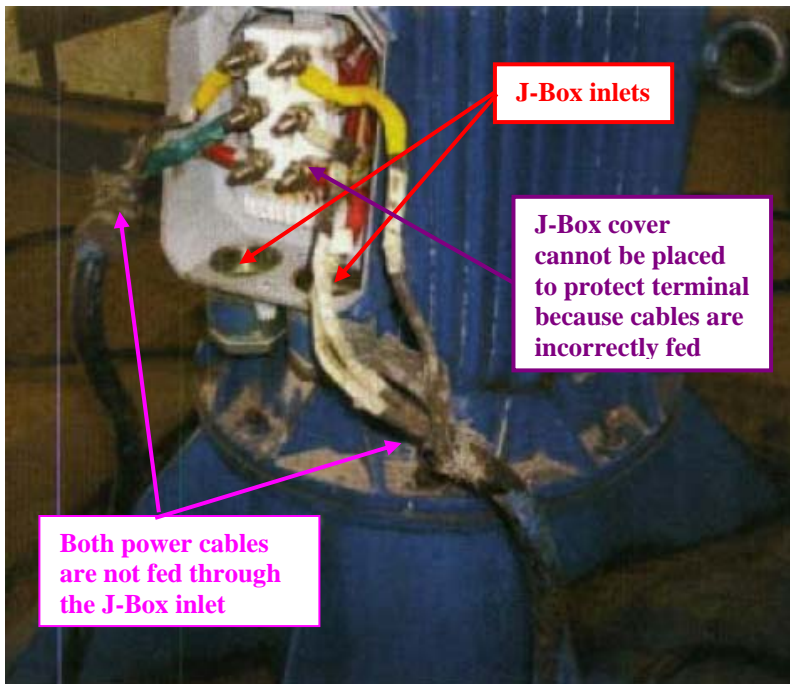
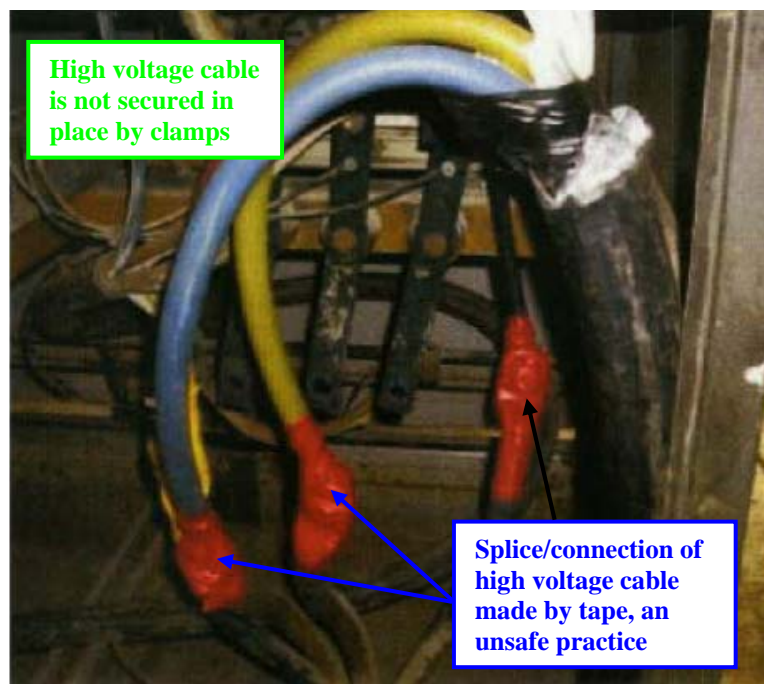
A review of the photographs taken during the final inspection provides insight into the installation techniques and practices employed by the Phase 3 contractor. For example, the contractor used very poor and potentially dangerous installation techniques while attempting to connect a vertical pump motor (Site Photo 6) and the 100 mm submersible pump control panel (Site Photo 7). Finally, the USACE representative performing the final inspection had to point out that an electrical fire within the 300 mm vertical pump control panel necessitated repair of the control panel (Site Photo 8). The electrical fire is evidence of poor installation techniques used by the contractor.

Site Photos 6 and 7. Dangerous installation connecting the vertical pump motor and the 100 mm submersible pump control panel.
(Photos courtesy of USACE)

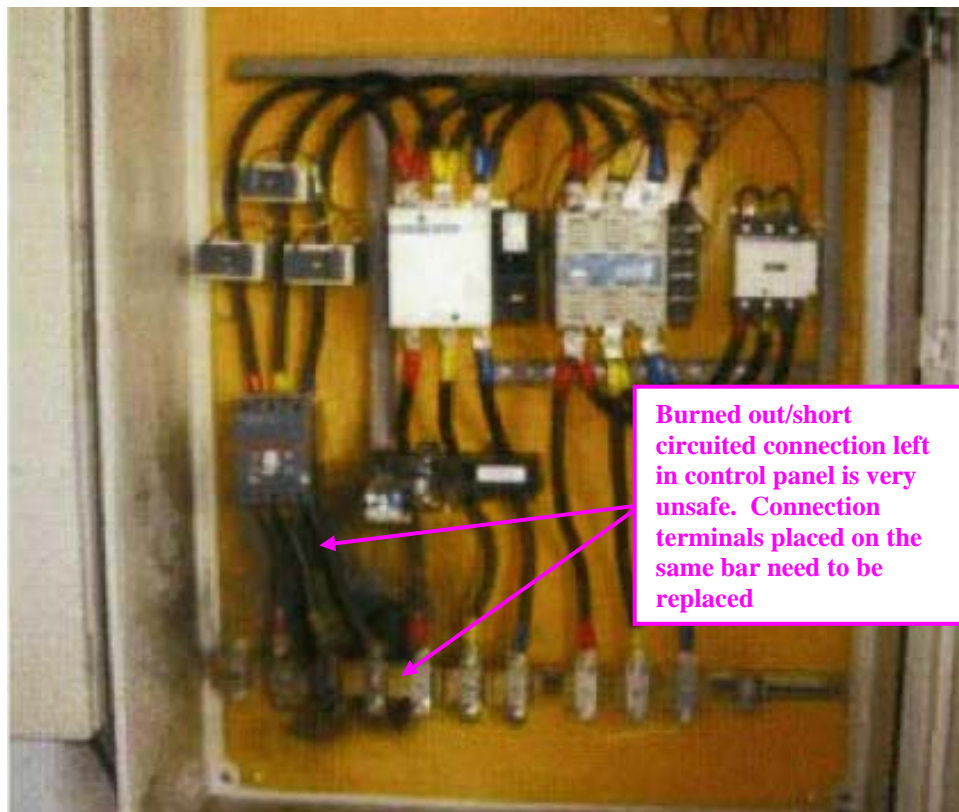
Site Photo 8. Electrical fire within the 300 mm vertical pump control panel.
(Photo courtesy of USACE)

Without detailed QC and QA daily reports to document the installation techniques employed by the contractors, we cannot determine if any of the vertical pumps were properly installed. Considering at least one vertical pump, in less than two years, needed to be replaced twice and serviced once, it appears two contractors did not properly install the pump. The contract files do not mention the reason why the new pumps failed.

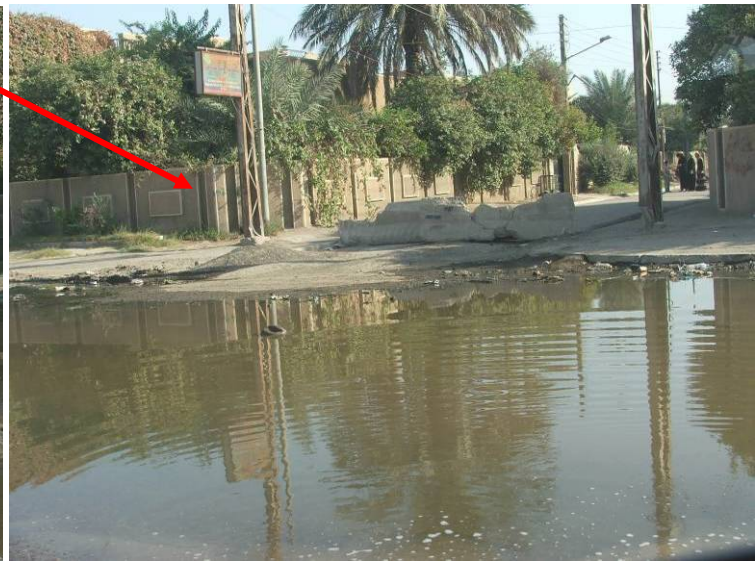
During our first site visit, we identified streets in the Al Amerea area with backed up sewer water and streets with no sewer water back up (Aerial Image 2 and Site Photos 9-11). While we conducted our site visit, a concerned resident of the area angrily complained about the backed up sewer water on his street.

Site Photos 10 and 11. Flooded streets in the Al Amerea area

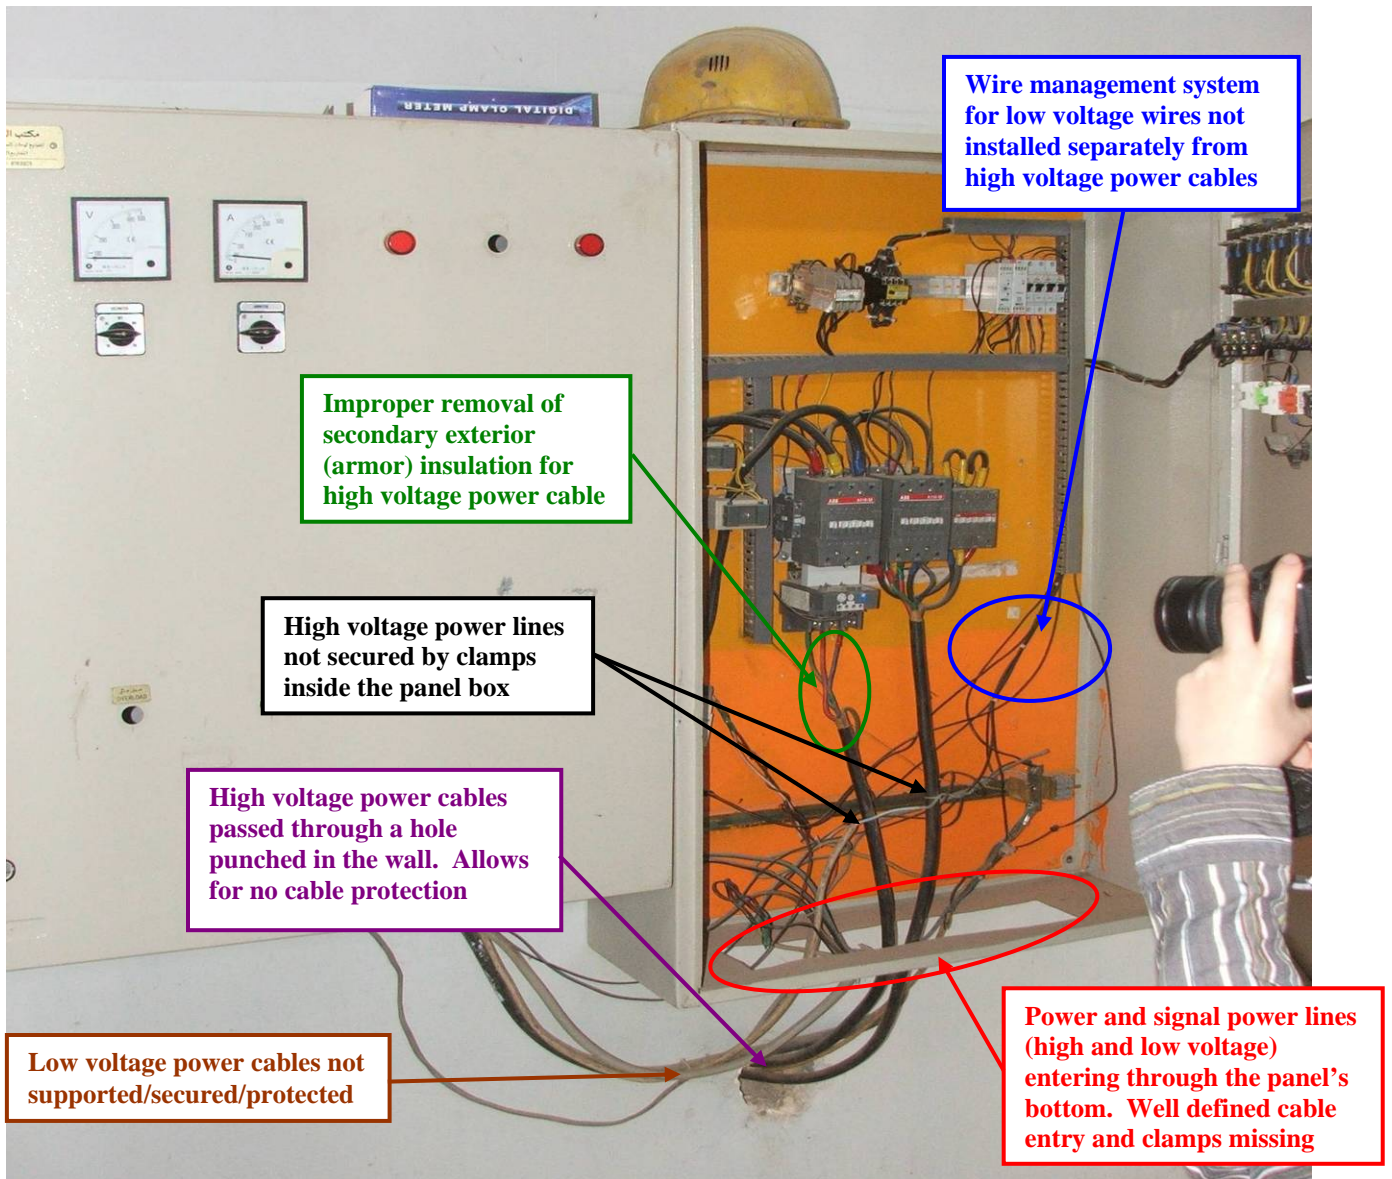
We located the control panel for the 300 mm submersible pump (Site Photo 14) and identified potentially hazardous electrical wiring techniques, which leaves the pump station at risk for either a malfunction or a fire. For example, high voltage power cables and low voltage signal cables dangle and cross each other, which increase the chance of pump and/or motor failure via electromagnetic disruption. In addition, one high voltage wire was terminated short, which increases the potential for an electrical fire.

Site Photo 14. Control panel for the 300 mm submersible pump

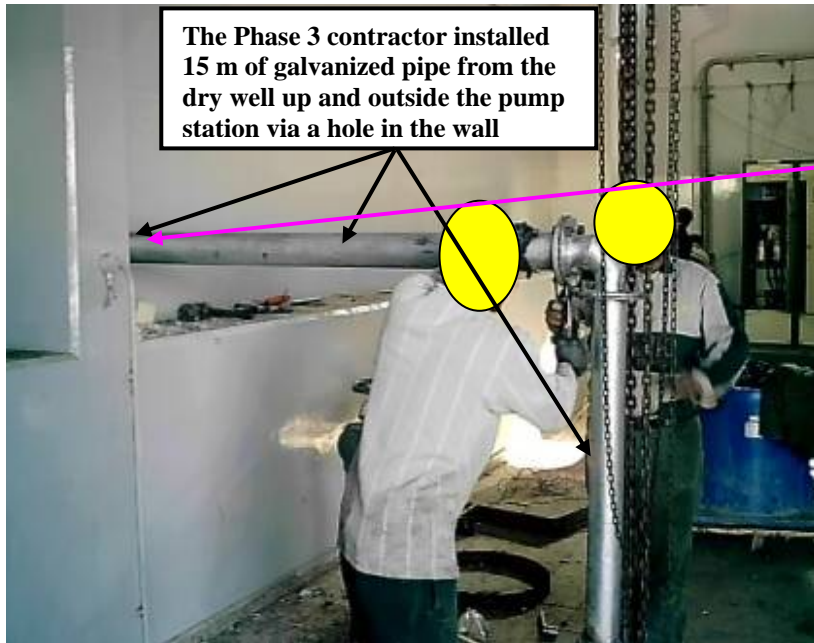
During our site visits, we first noticed that the galvanized pipe for the submersible pump that was installed by the contractor had been removed (Site Photos 15 and 16).

Site Photo 15. Installation of the 15m galvanized pump by the contractor. (Photo courtesy of USACE)

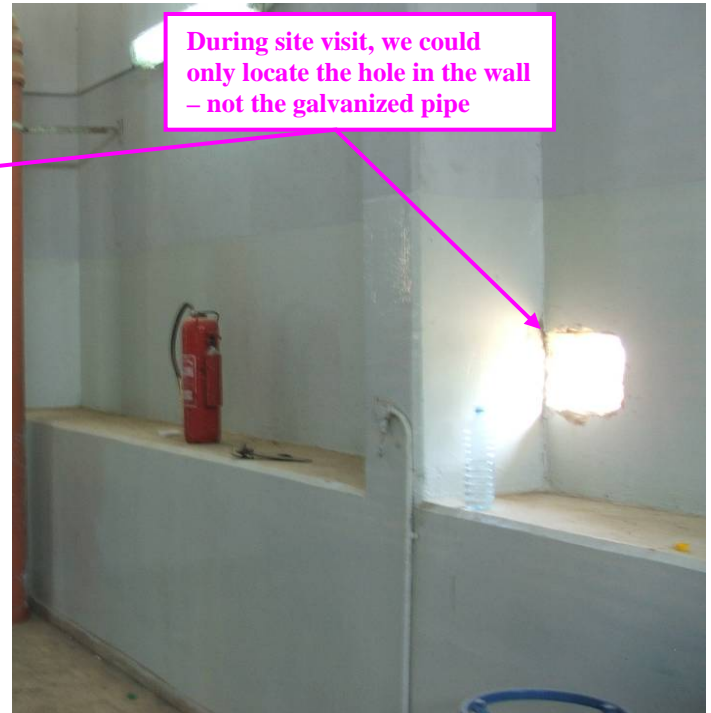
Site Photo 16. Location of where the 15m of galvanized pump and the 100mm submersible pump should be.

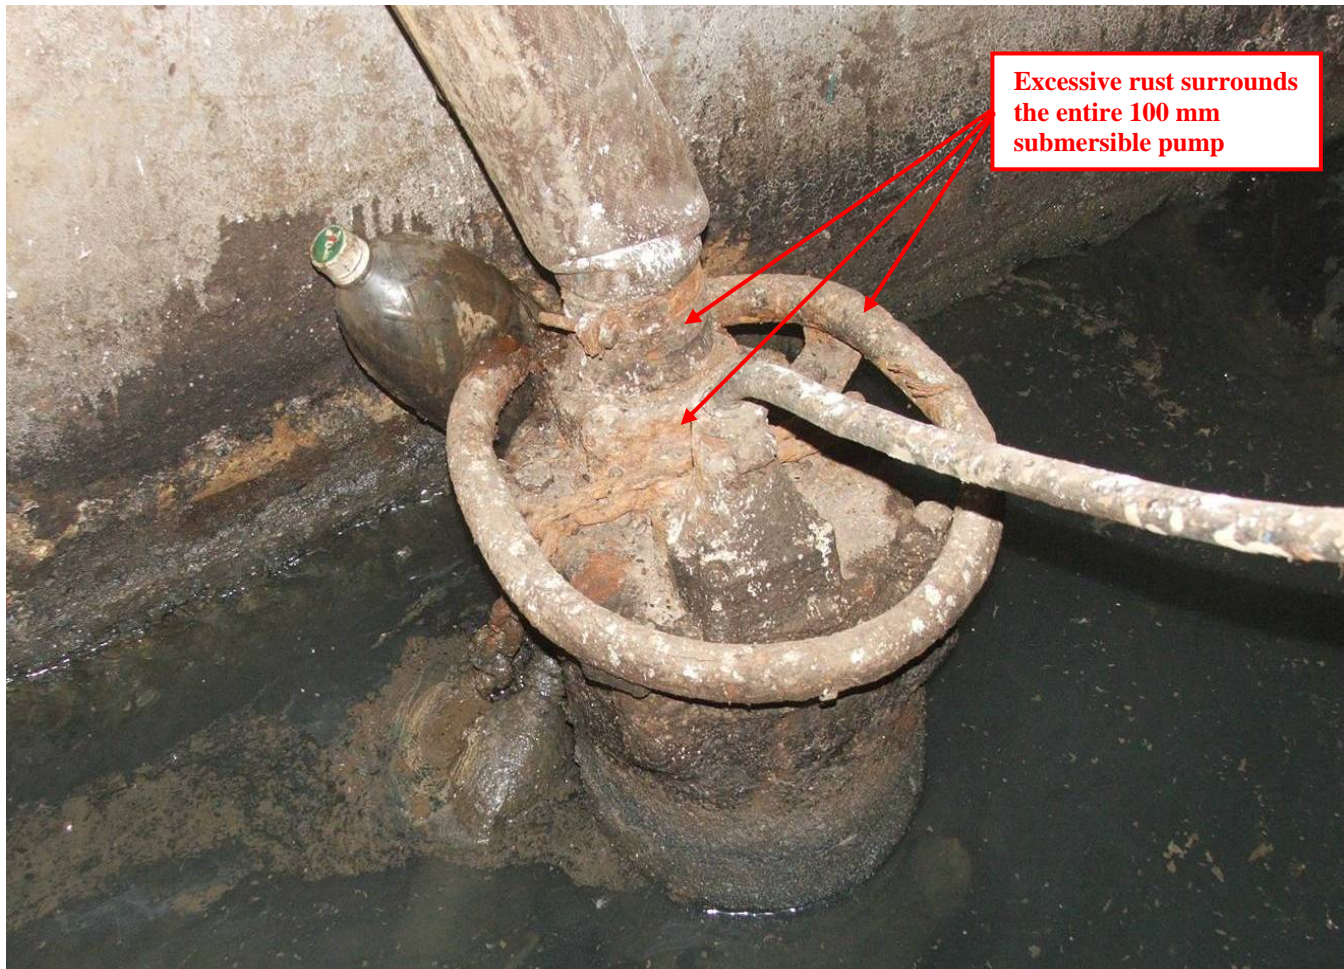
Inside the dry well, the pump station operator identified the 100 mm submersible pump (Site Photo 17), which was heavily rusted and corroded. We determined the submersible pump to be approximately 20-30 years old. The pump station operator stated this was the pre-existing submersible pump. Apparently, the galvanized pipe was never “installed” by the contractor; instead it was temporarily used to empty water within the dry well and then removed. The pump station operator stated a new submersible pump was never installed by the contractor and the current location of the galvanized pipes is not known. Consequently, the contractor was paid \$16,900 for a 100 mm submersible pump and 15 m of galvanized pipe not provided for the pump station.

Site Photo 17. Heavily rusted and corroded 100 mm submersible pump

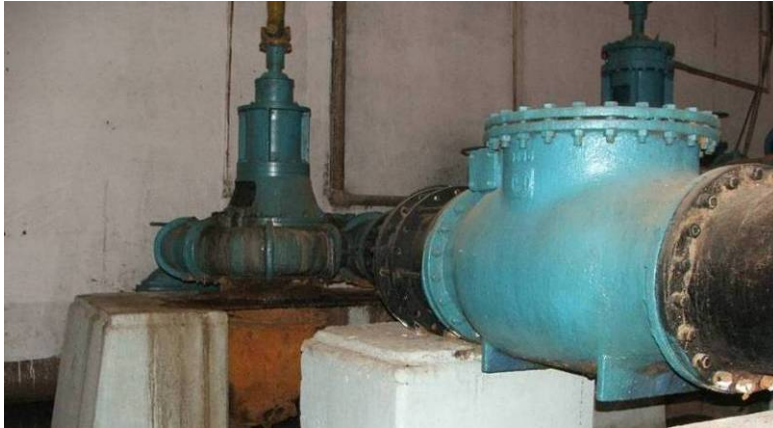
file, this pump was installed in March 2007; however, we identified significant amounts of rust and corrosion on this pump, which causes us to seriously doubt the claim this is a new pump. For example, the excessive amount of rust and grease around the nuts and bolts area is highly suspect for a “new” pump installed approximately 8 months ago (Site Photo 19). Also, the significant amount of water leakage from this pump causes us to believe this pump is either not new or not properly installed. A newly and properly installed vertical pump should not suffer from the significant water leakage we witnessed (Site Photo 20).

Site Photo 18. 350 mm vertical pump

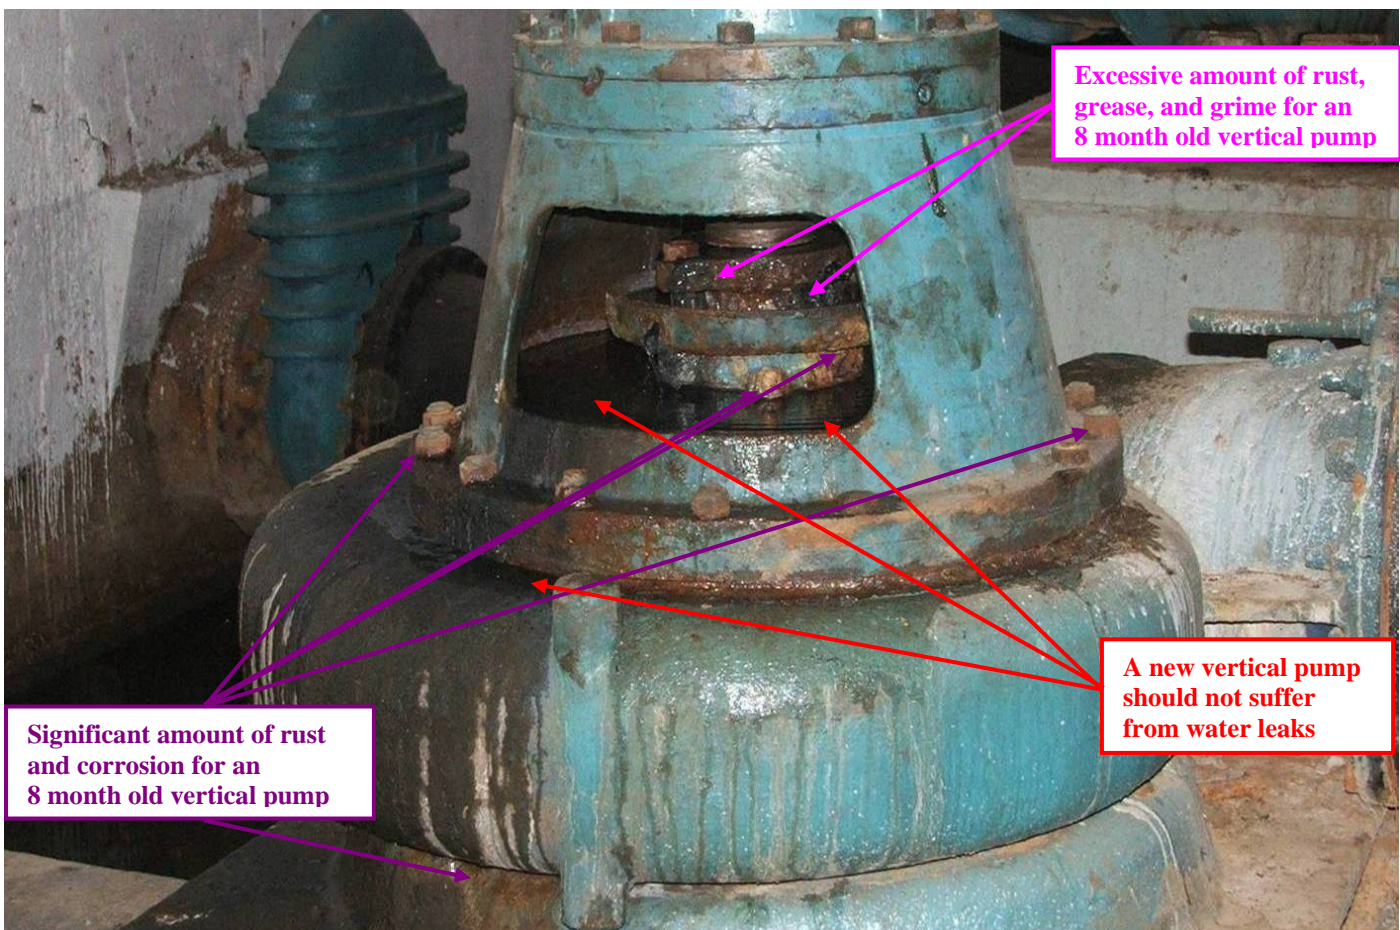
Site Photo 19. Rust indicates that the 350 mm vertical pump is either not new or not properly installed

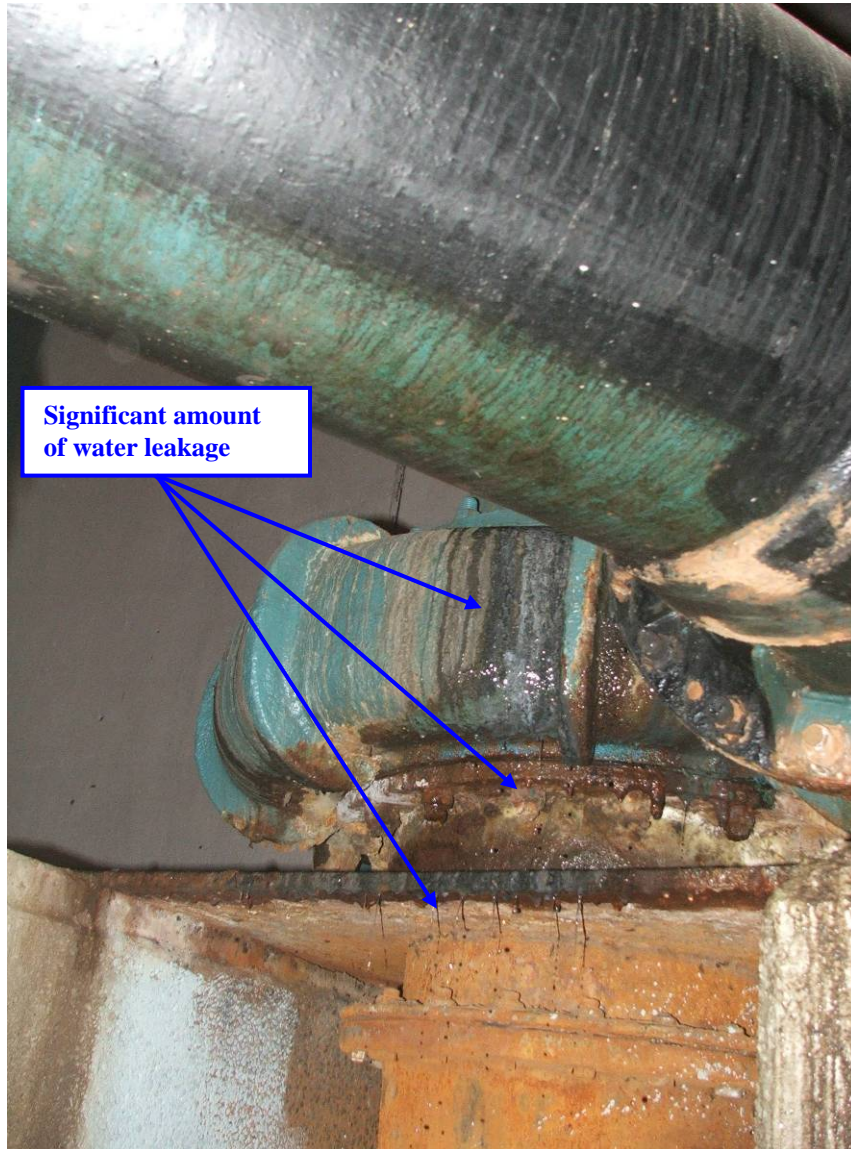
Site Photo 20. Significant water leaking witnessed from the 350 mm vertical pump

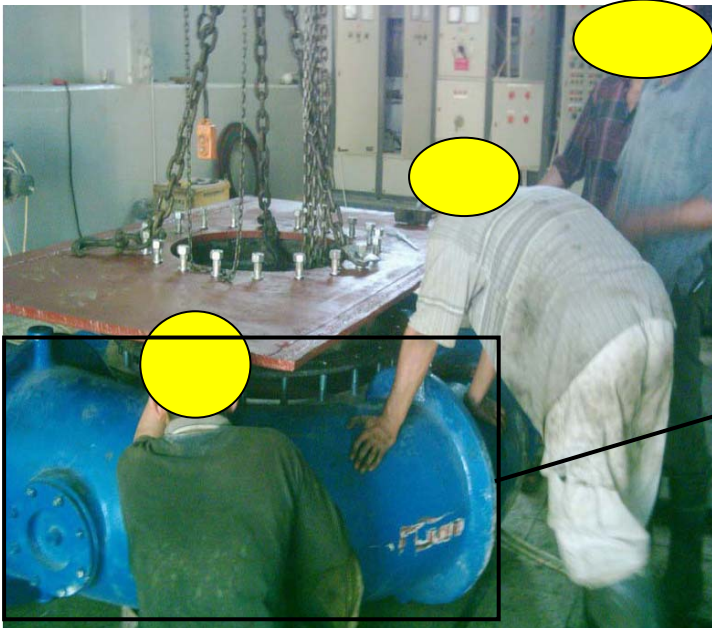
Without any contract file documentation to determine the condition of the vertical pumps prior to installation, we closely reviewed the vertical pumps from the QAR photographs. All we could determine was that, while sometimes cosmetically damaged, the vertical pumps appeared to be in relatively good condition (i.e. no rust or holes) (Site Photo 22).

Site Photo 22. View of the condition of 800 mm vertical pump installed by the contractor (Photo courtesy of the USACE)

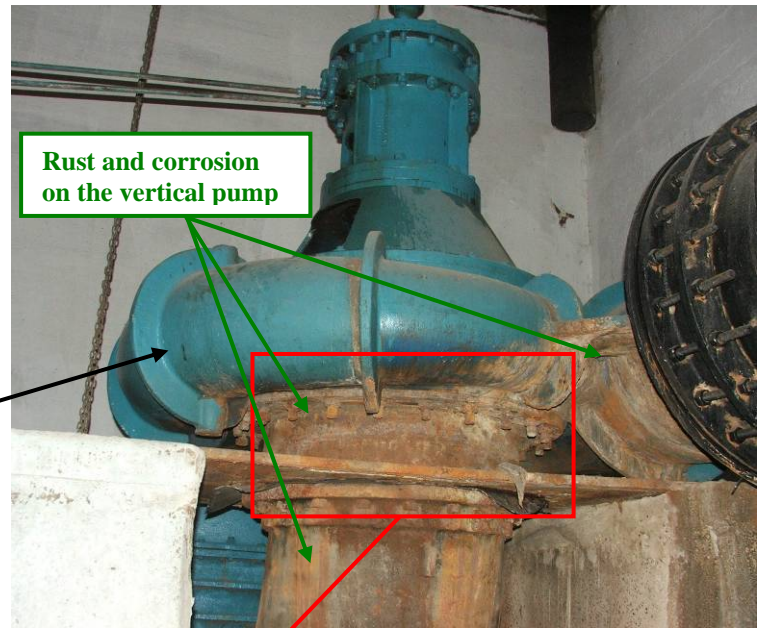
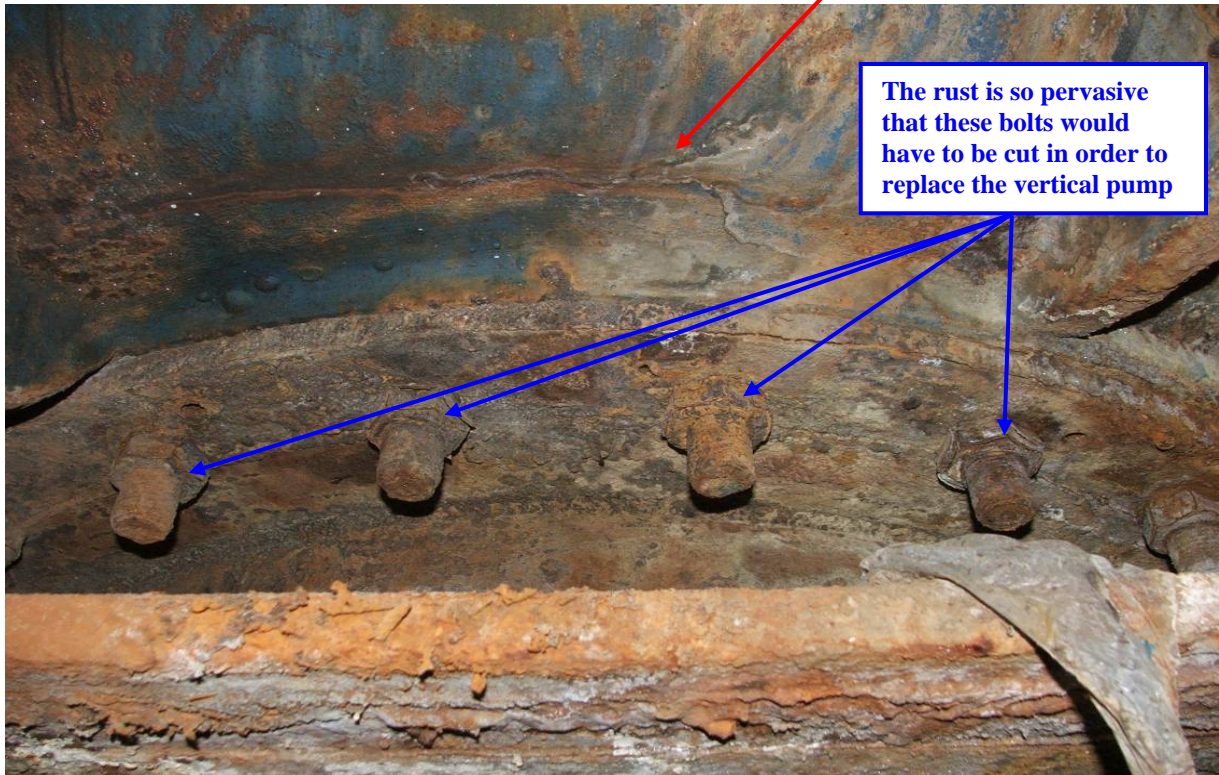
During our site visits, we identified significant amounts of rust on the bottom of all four vertical pumps and the nuts and bolts connecting the vertical pumps to the outlet pipes. For example, in the case of the 800 mm vertical pump, the bottom of the pump is severely rusted as well as the nuts and bolts connecting it to the outlet pipe (Site Photos 23 and 24). There are only two possible reasons to explain the significant amount of rust on the bottom of the newly installed vertical pumps – either the pumps installed were used (and previously rusted) or the contractor did not properly install the vertical pumps. Poor installation of the vertical pumps would result in water overflowing the pump causing rust to form.

Site Photo 23. View of rust SIGIR Inspectors witnessed on the same vertical pump

Site Photo 24. Close up view of Site Photo 23

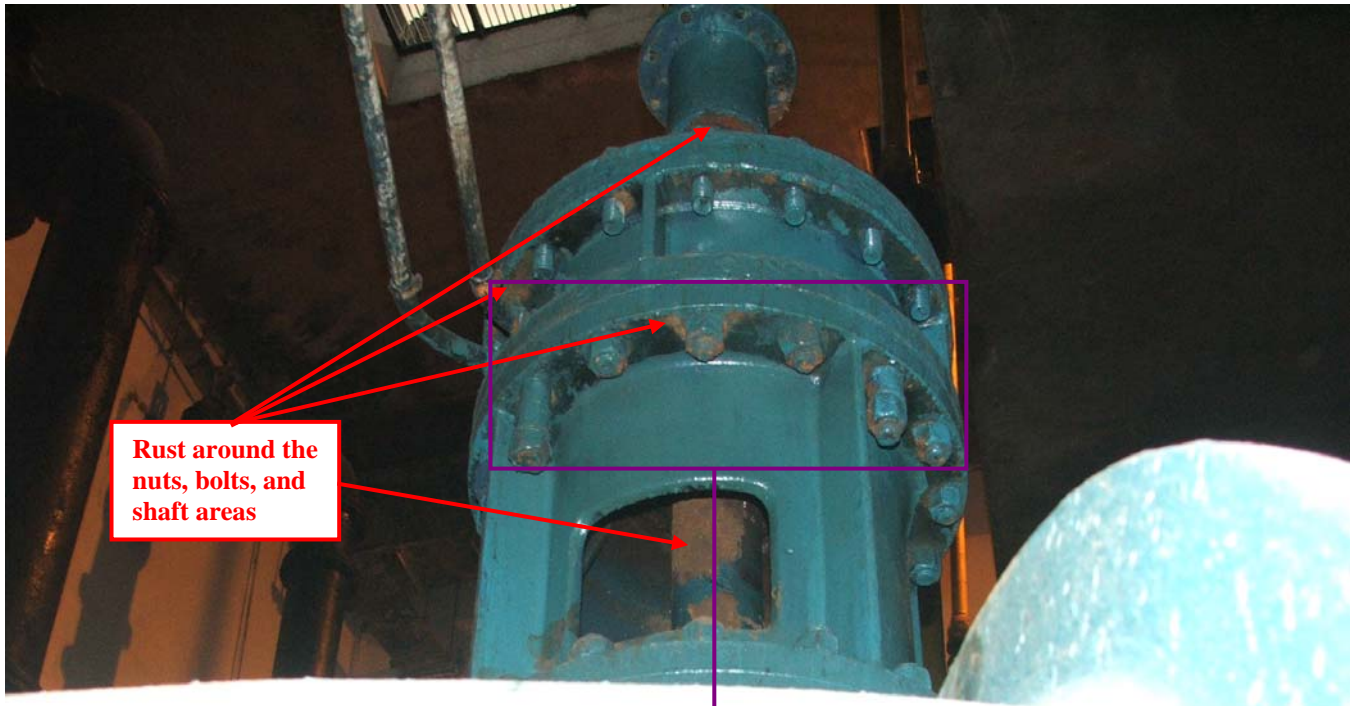
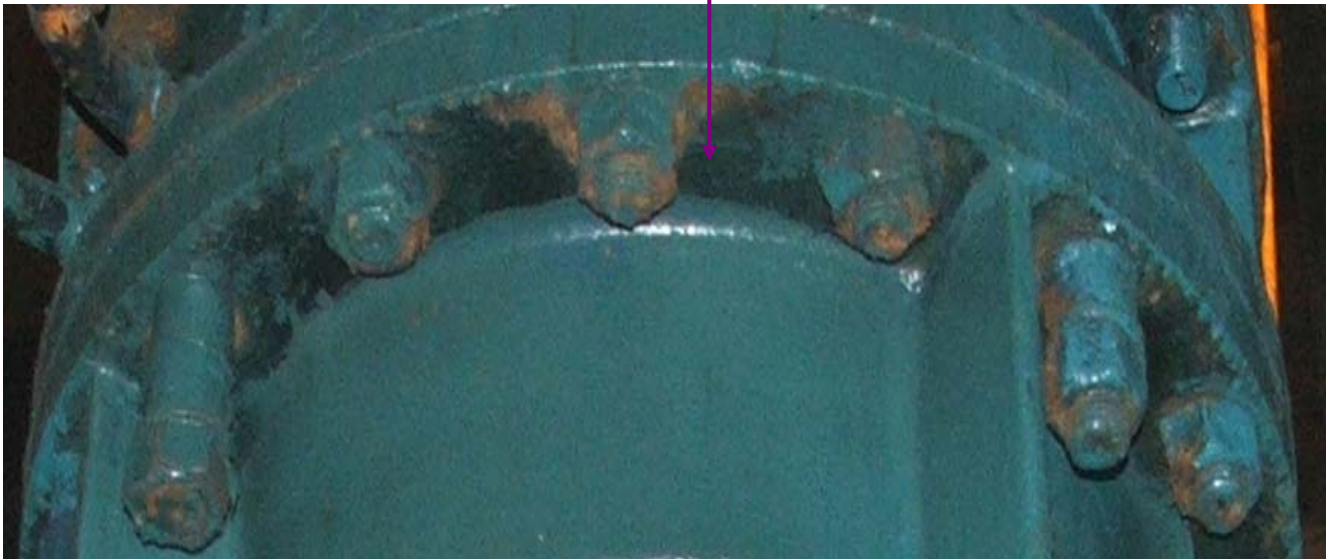
For the 600 mm vertical pump, we also witnessed a significant amount of rust for a pump that was installed in January 2006. The Phase 4 contract required the painting of the vertical pump; however, the excessive amounts of rust are visible through the paint, especially around the nuts and bolts and the shaft areas (Site Photos 25 and 26).

Site Photo 25. View of the 600 mm vertical pump

Site Photo 26. Close up view of Site Photo 25

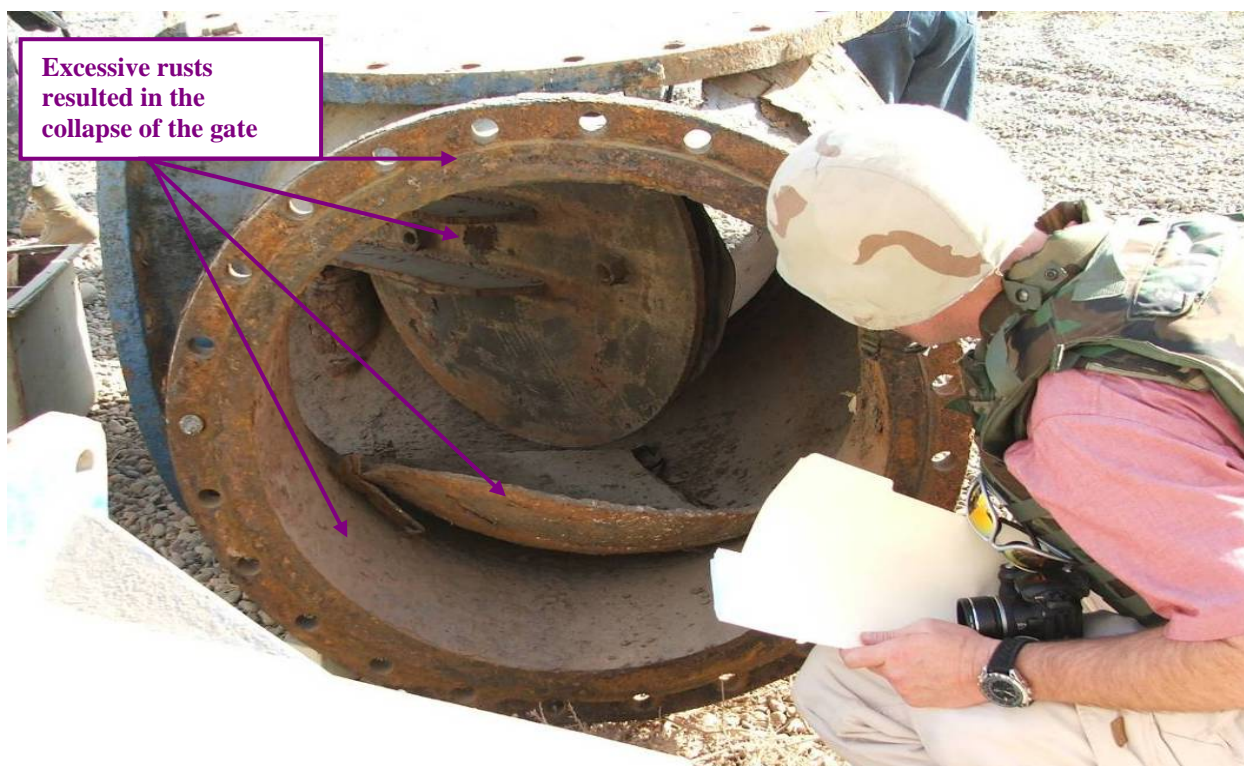
During our site visits, we identified the replacement of only the 800 mm vertical pump gate valve (Site Photo 29). The replacement gate valve is a different shape and size than the pre-existing gate valves, which required the contractor to reconfigure the connection with the outlet pipe from the vertical pump. According to the Phase 4 contractor, the original gate valve collapsed as a result of years of rust and corrosion (Site Photo 30).

Site Photo 30. View of the original gate valve for the 800 mm vertical pump

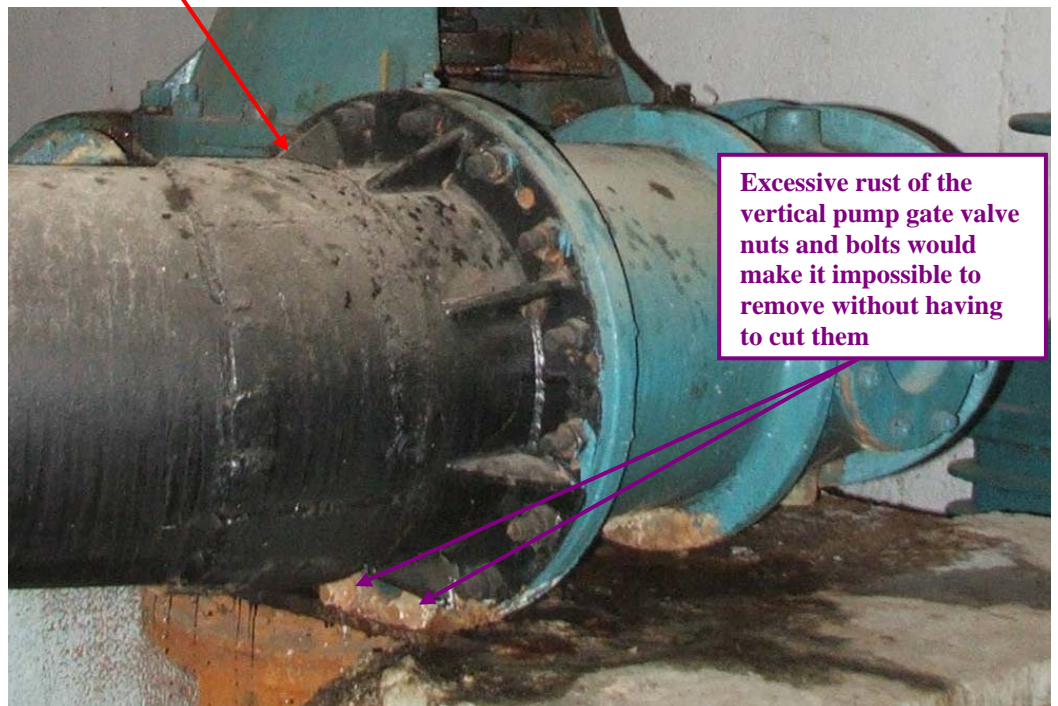
To make the determination of whether to repair or replace a vertical pump gate valve required the contractor to remove the gate valve and inspect it to see if significant rust and corrosion were present and also determine the quality of the nuts and bolts. We saw no evidence that the contractor attempted to remove the gate valves for the 350 mm, 500 mm, and 600 mm vertical pumps. For example, several nuts and bolts to the 350 mm vertical pump gate valve were so rusted that it would be impossible to remove them without cutting them off (Site Photos 31 and 32). The only work performed by the contractor for these three vertical pump gate valves was painting.

Site Photo 31. View of 350 mm vertical pump gate valve

Site Photo 32. Close up view of Site Photo 31

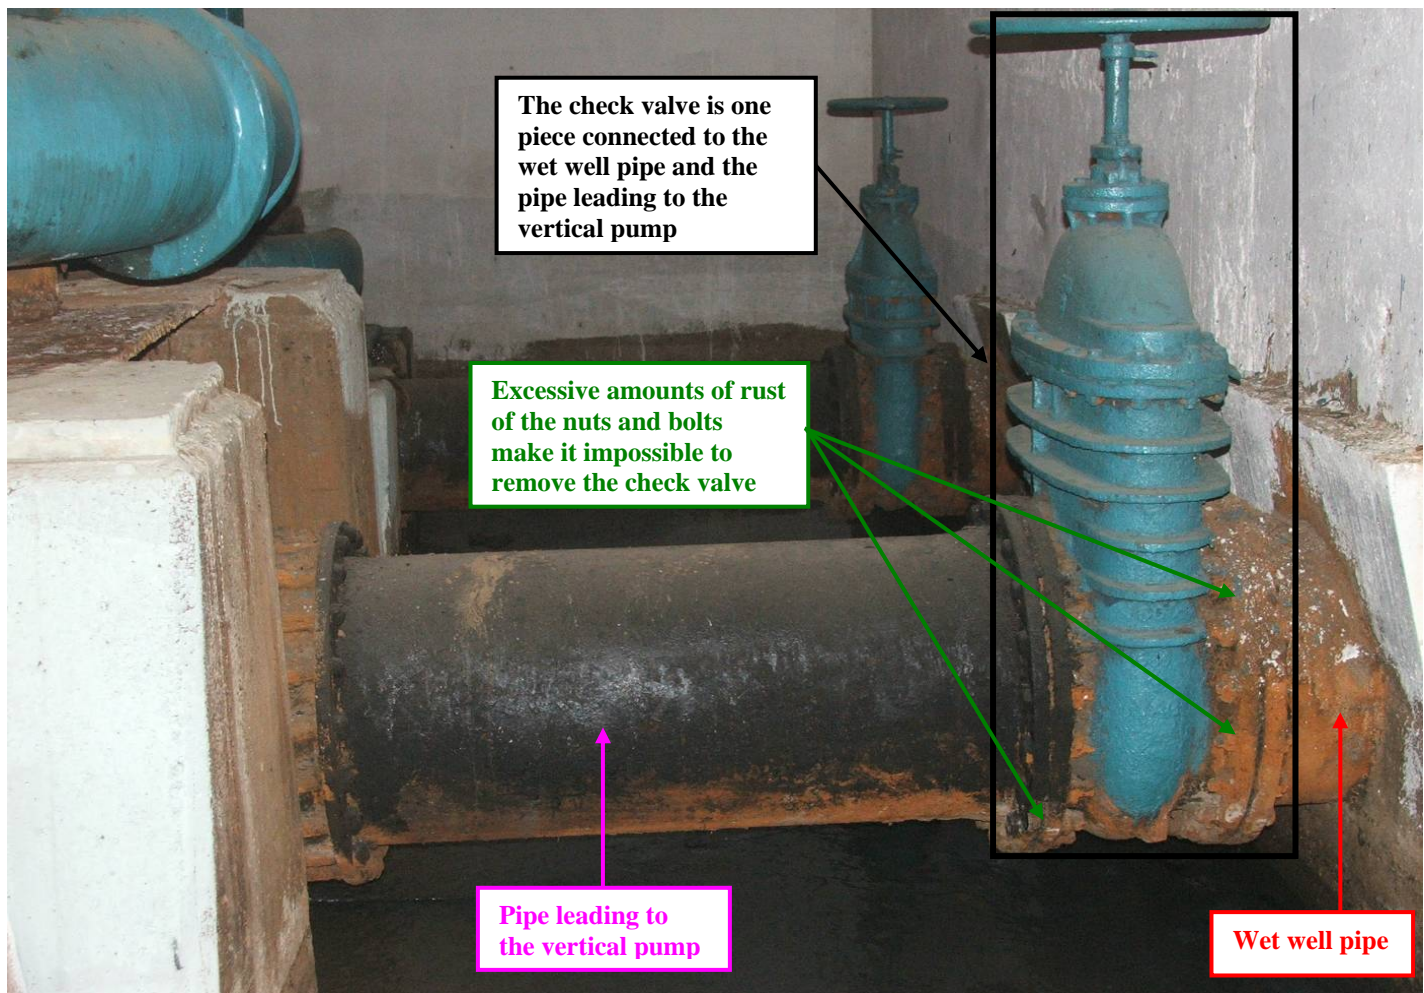
As with the gate valves, the rehabilitation of check valves would require the contractor to remove each one to determine if significant rust and corrosion were present. For the check valves, we also saw no evidence that the contractor did anything except paint over the rust on the existing valves. For example, the 350 mm and 500 mm vertical pump check valves are so significantly rusted onto the inlet and outlet pipes that there is no possible way it could have been removed and inspected (Site Photo 33). It appears the contractor only painted over the rust on the pre-existing check valves.

Site Photo 33. View of the check valves for the 350 mm and 500 mm vertical pumps

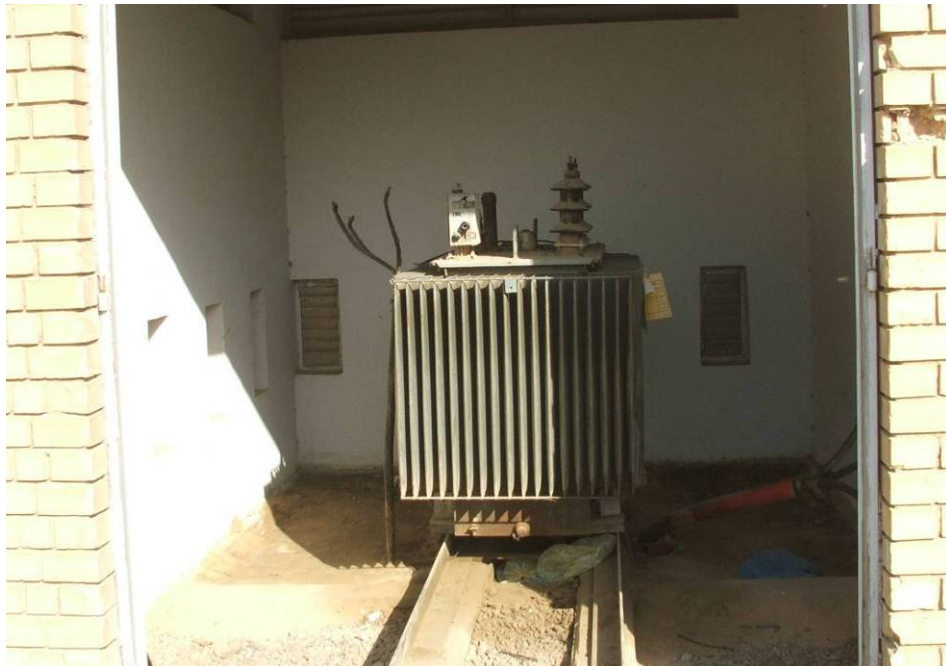
According to 2-1 ID personnel, an 11 kilo-Volt (kV)/3.3 kV (850 kVA) transformer is needed to capture electrical power through the national grid to operate the 600 mm and 800 mm vertical pumps.

Site Photo 34. Pump station's old and poorly maintained transformer.

1. Provide and install a step-down 11 kilo-volt /3.3 kilo-volt (850 kilo-volt Ampere) transformer with all required cables, main power panel, breakers, sub-panels, distribution panels and control panels for the Mansour Pump Station to capture and use available power from the national grid to operate the 600 millimeter and 800 millimeter vertical pumps.
2. Determine whether the various existing vertical pumps, motors, and associated components at the Gulf Region Central facility are still functional. If they are functional, house them in an area safe from environmental conditions and determine an appropriate project for them.

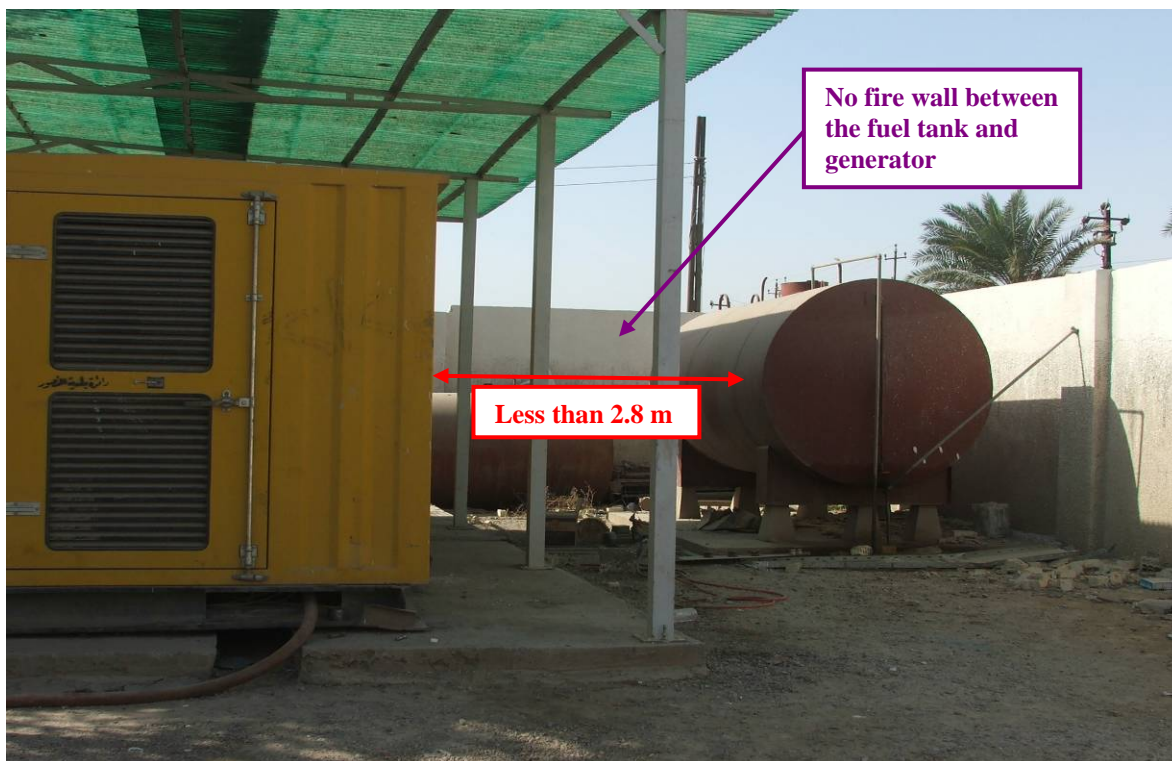
During the site visits, we identified the fuel tank and determined that it was still not located between the two generators and a fire rated wall was not constructed between it and the 750 kVA generator (Site Photo 35). Even though the daily QA report identified an instance when the contractor did not perform according to the contract's requirements, no action was taken against the contractor by the USACE. Consequently, the fuel tank is not located centrally between the two generators and continues to pose a potential fire hazard for the pump station.

Site Photo 35. Location of the pump station fuel tank
